CONTAINER DAMAGE REPORT

DISCHARGED VESSEL YARD	MV. <u>ANNIE B</u> LOCATION :	CONTAINER NUMBER <u>MMAU 132554-0</u>
---------------------------	----------------------------------	--

CONTAINER DAMAGE REPORT & NOTICE OF LIABILITY

Vessel's Name: M.V. ANNIE B		
Container No: MMAU1325540		VOYAGE No.: 013
Report date: 16.06.2026	Port: AT SCCT, PORT SAID	Berth No: 07
Load port: PORT SAID EAST	Discharge Port: CONSTANTA	Stowage Position: 420206
Cargo spill / leakages (if any)	NO

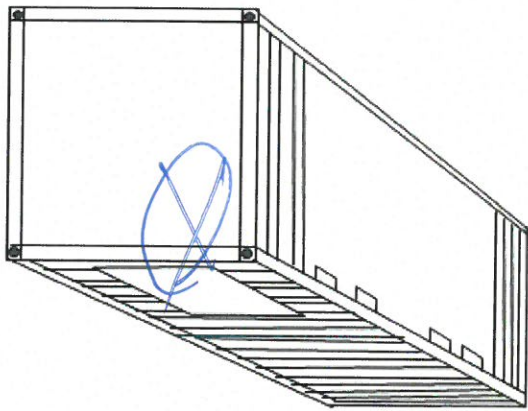
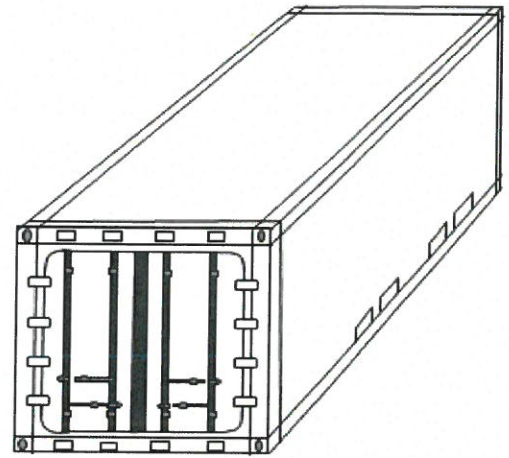
<input checked="" type="checkbox"/> D DENTED	L LEAKING	<input checked="" type="checkbox"/> C CUTTED
T TORN	R RIPPED	S SCRATCHED
H HOLE	W HEAVILY RUSTED	I IMO LABEL
C CORNER	D DOOR	B BOTTOM
<input checked="" type="checkbox"/> F FRONT	R RIGHT	T TOP
A BACK	L LEFT

CONTAINER - MMAU 132554-0 was damaged, while loading in Port Said, CDR present onboard, signed by SCCT, Port Said. CDR presented to chief officer

Above container discharged in damage as per exceptions noted above

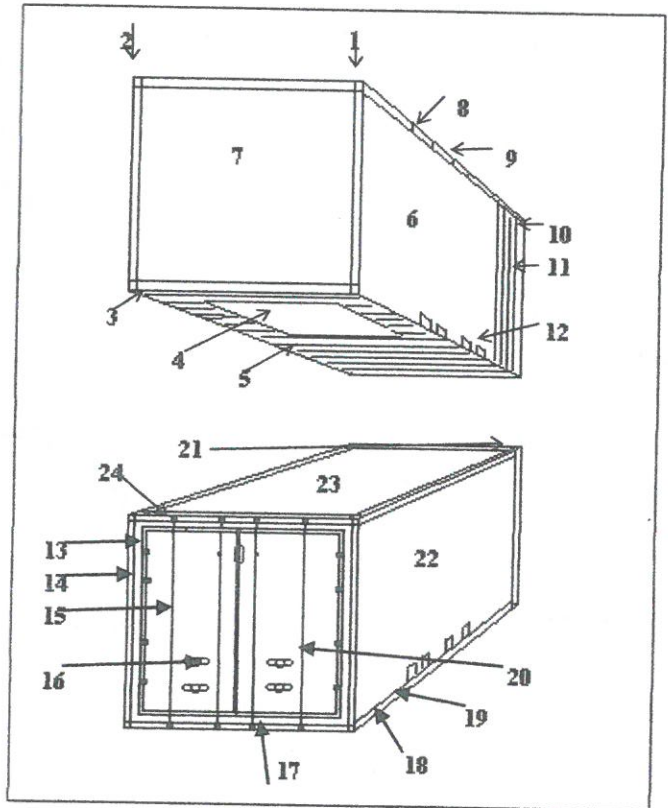
DAMAGE DETAILS: During loading reefer MMAU1325540 on Bay 42 row 02 tier 06 got hit on cell guide head and rear bottom rail dented and reefer components got distorted.

CAUSE OF DAMAGE: Rough handling of crane operator
