Vanning Survey Report

Shipper:	Noraka investment CC
Description of goods:	Lump Charcoal
Vanning location:	Otiwarongo-Namibia, Noraka Warehouse
Vanning site coordinates:	20° 27' 13.382" S 16° 38' 21.718" E Datum (WGS-84) DDD MM° SS.S"
Shipping carrier:	MAERSK
Booking reference:	261340901
Port of loading:	Walvis Bay – Namibia
Port of discharge:	Jeddah/Saudi Arabia

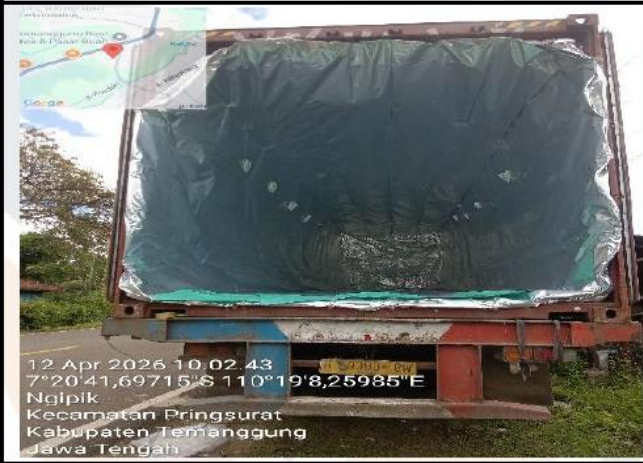
VIEW OF INNER STRUCTURES OF CONTAINER

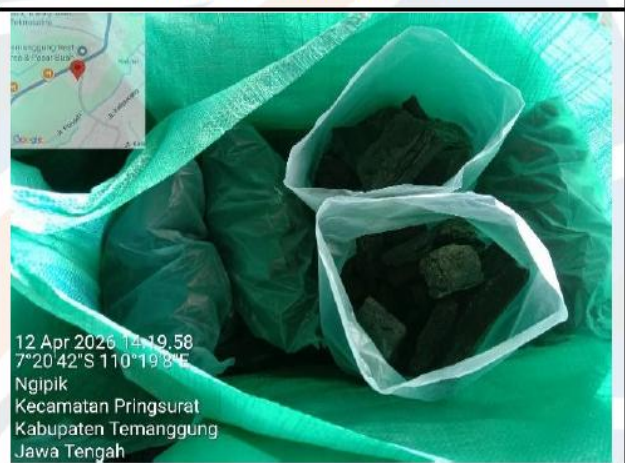
VIEW OF CARGO IN PACK

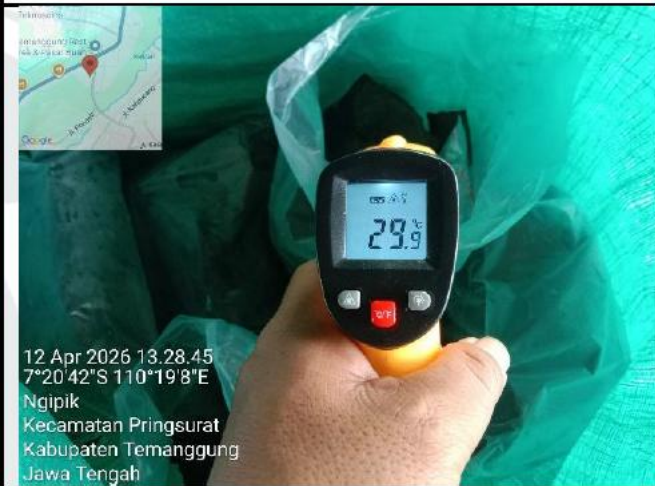
VIEW OF CARGO TEMPERATURE

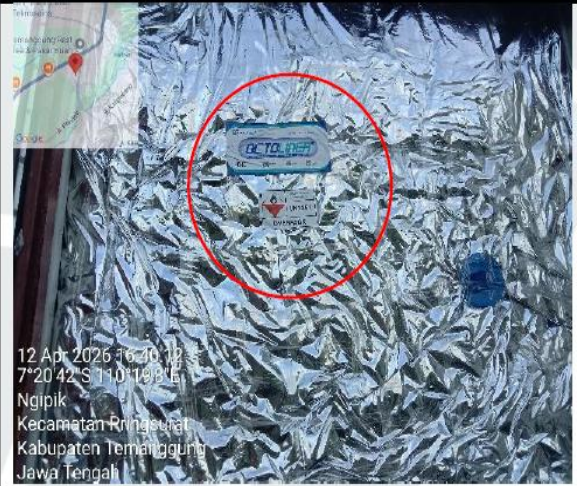
VIEW OF OVERPACK STICKER

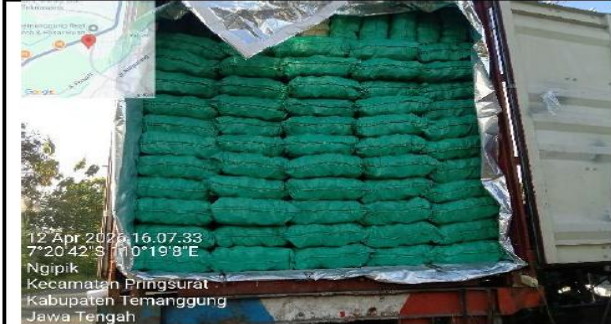
VIEW OF FULL CARGO LOADED BEFORE THERMAL CLOSURE ON CONTAINER

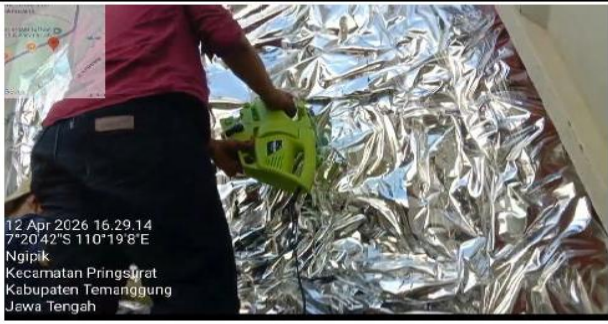
VIEW OF VACUUM PROCESS

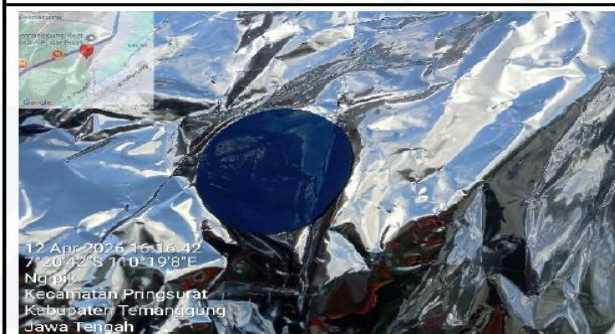
VALVE INSTALLED PROPERLY

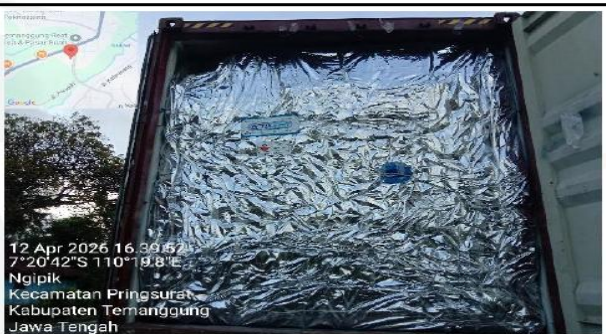
VIEW OF FULL CARGO AFTER VACUUMED
