CONTAINER DAMAGE REPORT

DISCHARGED VESSEL YARD	MV. <u>ANNIE B</u> LOCATION :	CONTAINER NUMBER <u>MMAU 132554-0</u>
---------------------------	----------------------------------	--

CONTAINER DAMAGE REPORT & NOTICE OF LIABILITY

Vessel's Name: M.V. ANNIE B		
Container No: MMAU1325540		VOYAGE No.: 013
Report date: 16.06.2026	Port: AT SCCT, PORT SAID	Berth No: 07
Load port: PORT SAID EAST	Discharge Port: CONSTANTA	Stowage Position: 420206
Cargo spill / leakages (if any)	NO

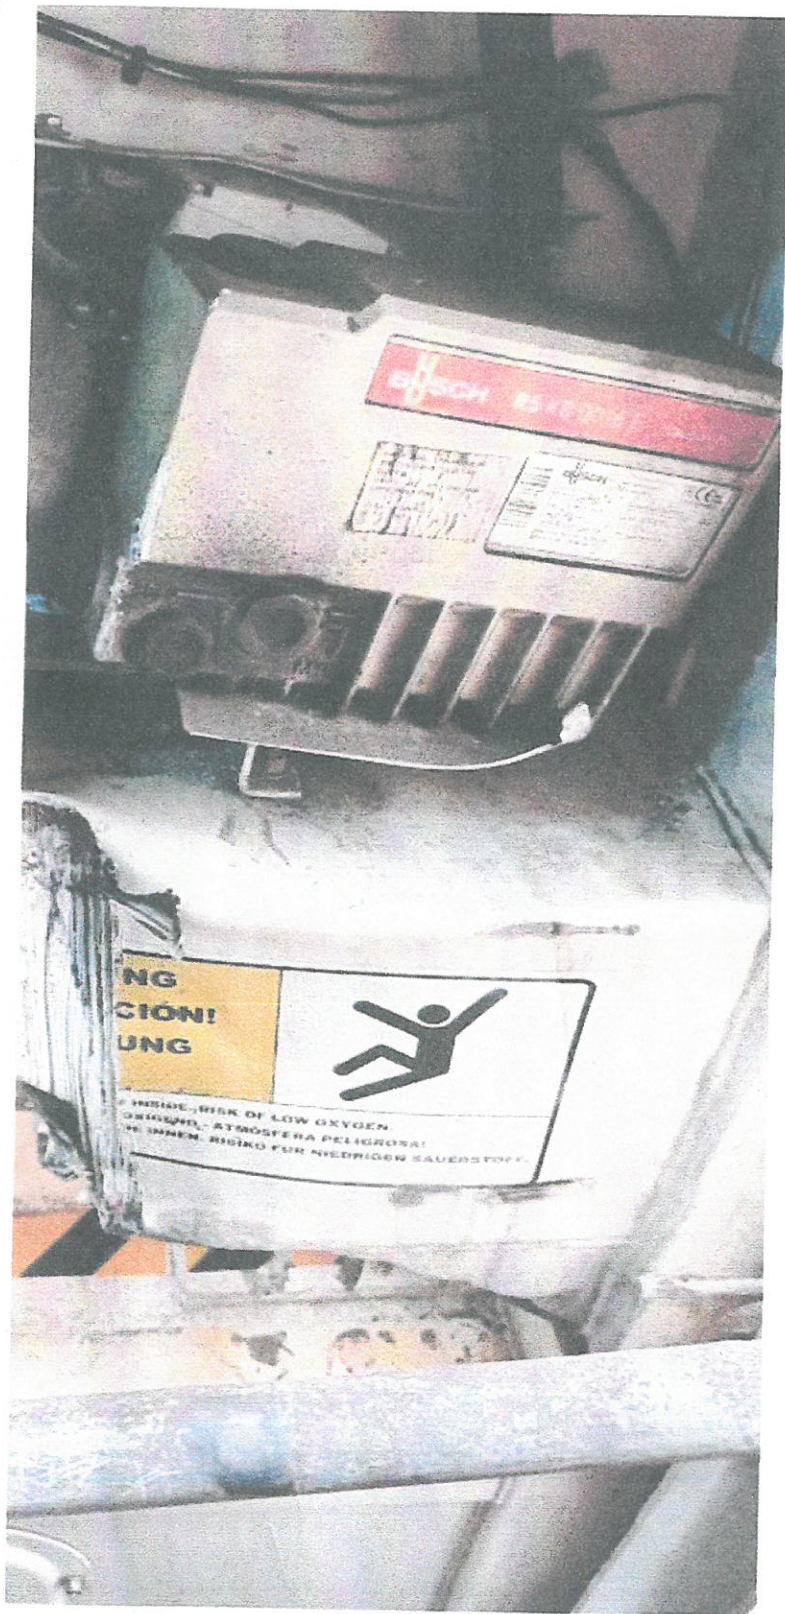
DAMAGE DETAILS: During loading reefer MMAU1325540 on Bay 42 row 02 tier 06 got hit on cell guide head and rear bottom rail dented and reefer components got distorted.

CAUSE OF DAMAGE: Rough handling of crane operator
